A Green Renovation of a Historic Nantucket Building: *Mitchell's Book Corner*

White Paper Vol.1 August 2009

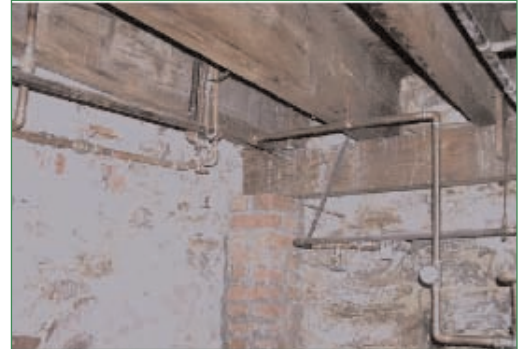
To reinforce the existing structure:

- *Supportive steel beams were introduced along the east and west walls perpendicular to the floor joists to properly bear the 150-pound per square foot load of books. Alternatives were considered, but each would have resulted in much deeper beams, many more posts, and a significant number of additional footings in the basement of the structure, leading to alteration of the interior spaces. All but one of the steel beams is hidden in the basement ceiling minimizing the visual impact of reinforcing the floors.*
- *In the attic plywood gussets were added and engineered lumber sistered to the existing purlins.*
- *At the second ceiling level, metal joist hangers were added.*
- *The roof truss structure, joists and sheathing remain intact.*
